HOME INSPECTION REPORT

Frisco Tx 75033

PROPERTY INSPECTION REPORT

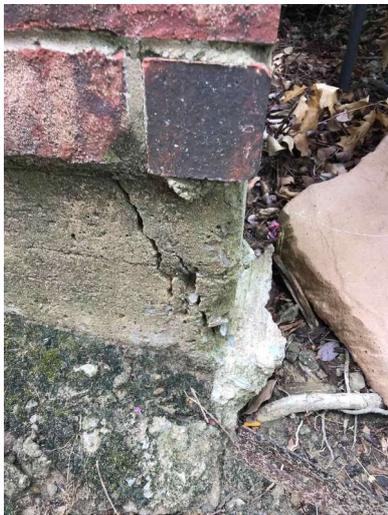
1: Corner Pop(s)

- Corner pops are present at some corners of the foundation (this is considered a cosmetic issue and should not affect performance of foundation)

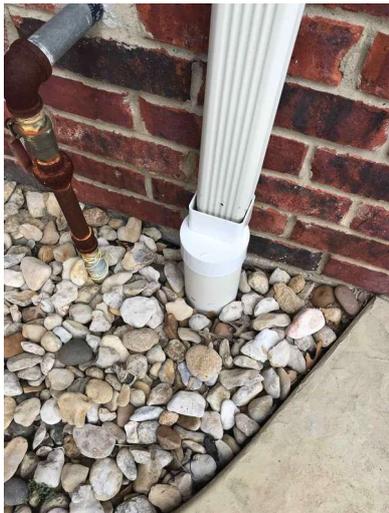
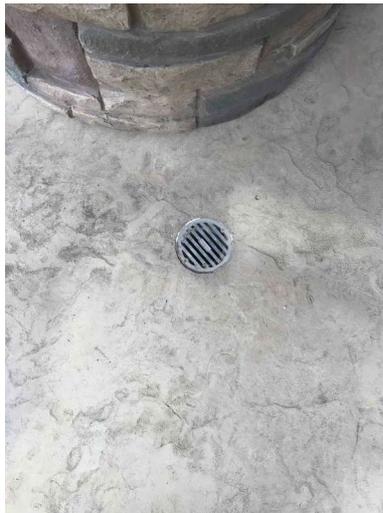
Underground Drainage Present:

Underground drains have been installed around the pool area and back porch to assist with drainage. Drains appear to be functioning as intended at time of inspection, but underground drains are not tested so I cannot determine how effectively the drains perform

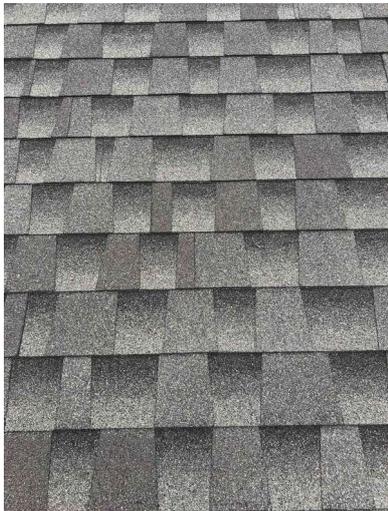
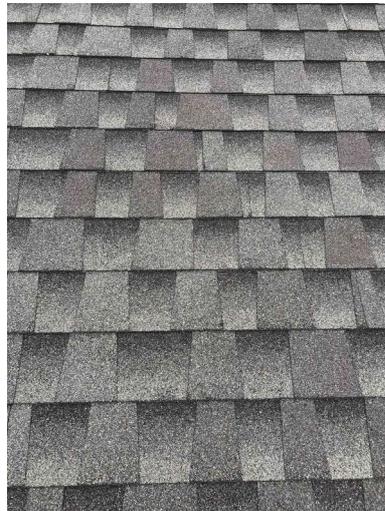
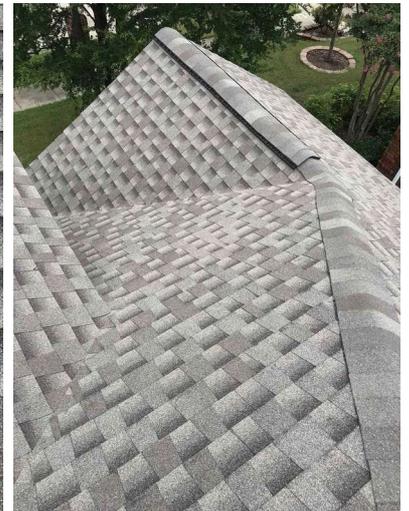
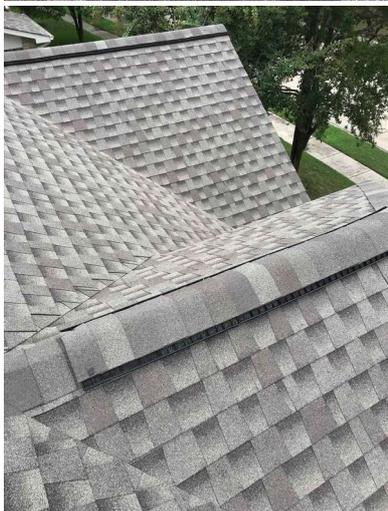
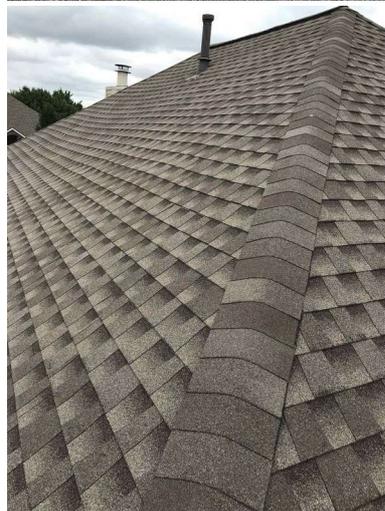
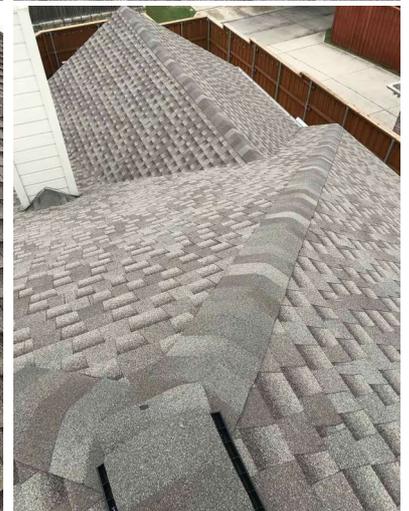
Shingle Condition: Overall condition of shingles appears good and roof appears to be performing as intended

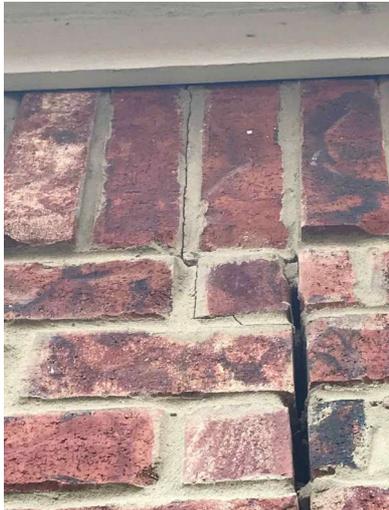
1: Exterior - Mortar Cracks

- Slight cracks present in mortar in exterior walls

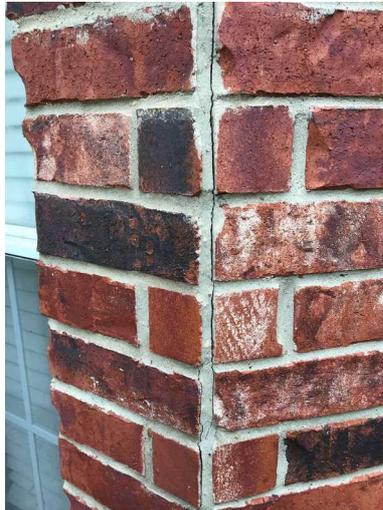
2: Exterior- Mortar Missing

- Mortar has chipped and fallen away from exterior wall at several spots, leaving slight opening in walls. I recommend client re-seal with mortar or caulk to fill openings and prevent water penetration into walls

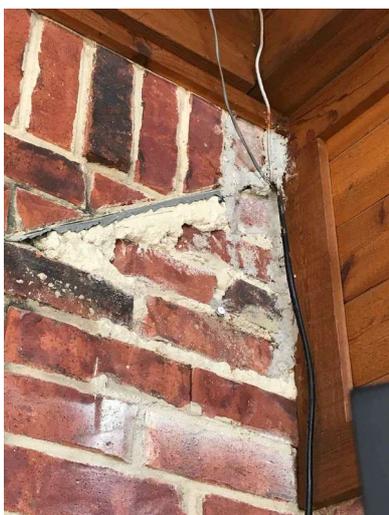
3: Exterior- Prior Patches/ Repairs

- Evidence of repair patch at upper corner of back porch area

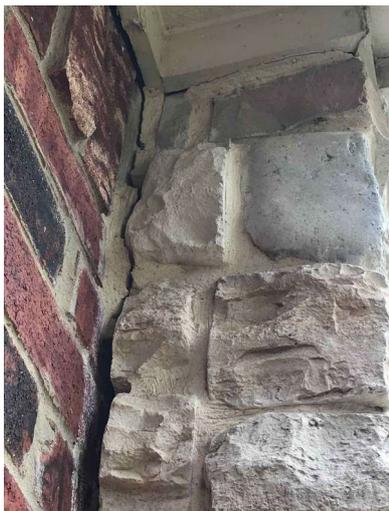
4: Exterior - Separations

- Separation has occurred at seam between the brick and stone near the corner of the front entry porch

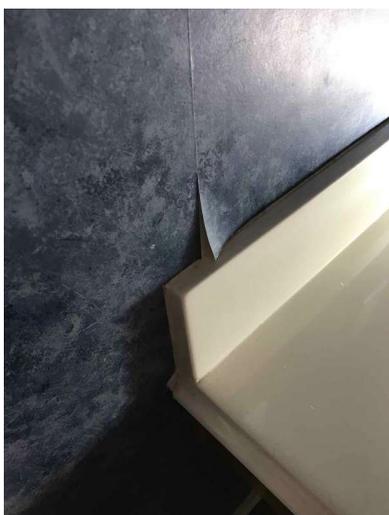
5: Interior- Damaged Walls

- Wallpaper is peeling slightly at corners in multiple places around the house

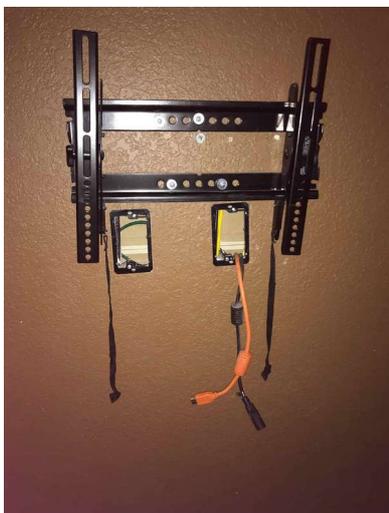
6: Interior - Opening in Wall

- Open holes have been cut in the master bedroom wall for TV cables

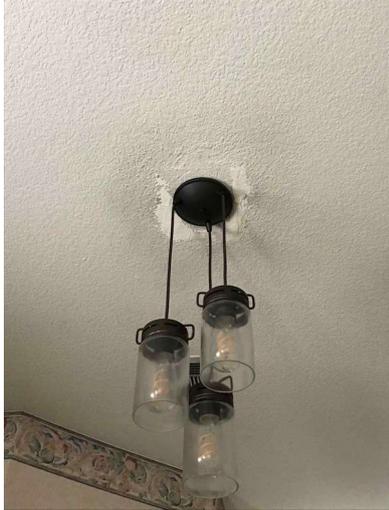
1: Ceiling Patch / Repairs

- Minor repairs / patches in ceiling drywall around kitchen light fixture and in the garage ceiling

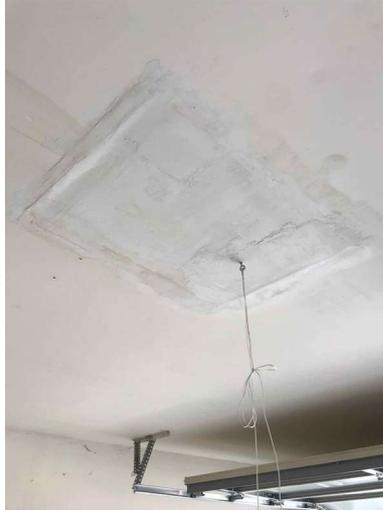
2: Ceiling Water Penetration

- Evidence of possible water penetration, stains in kitchen and in several places in the garage ceiling. I tested stained areas with a moisture meter, stained areas show to be dry (low moisture content consistent with other ceiling drywall). This appears to be a past issue but I cannot conclusively determine source of staining or if any ongoing water leaks may be present

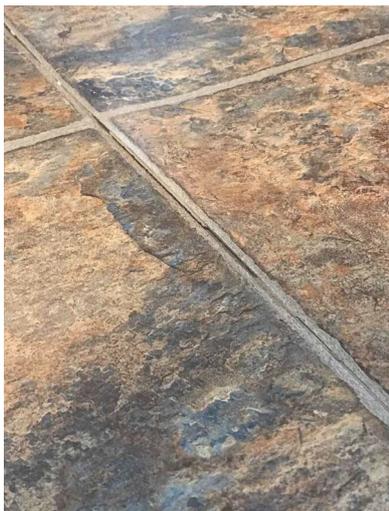
3: Floor - General Deficiency

- Master bathroom floor is vinyl “peel and stick” squares. Some vinyl tiles are loose and peeling upward along edges of tiles

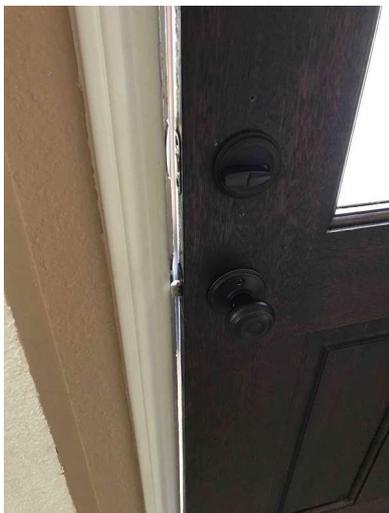
- Front entry door knob is not fully latching in door frame. Needs hardware adjustment.

Note: door is locked by using the deadbolt, so this does not affect the security of the door

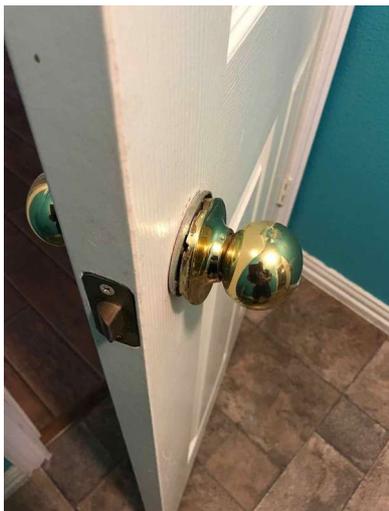
2: Door Hardware Broken / Damaged

- Decorative door knob trim cover on laundry room door is damaged; this does not affect the operation of the door

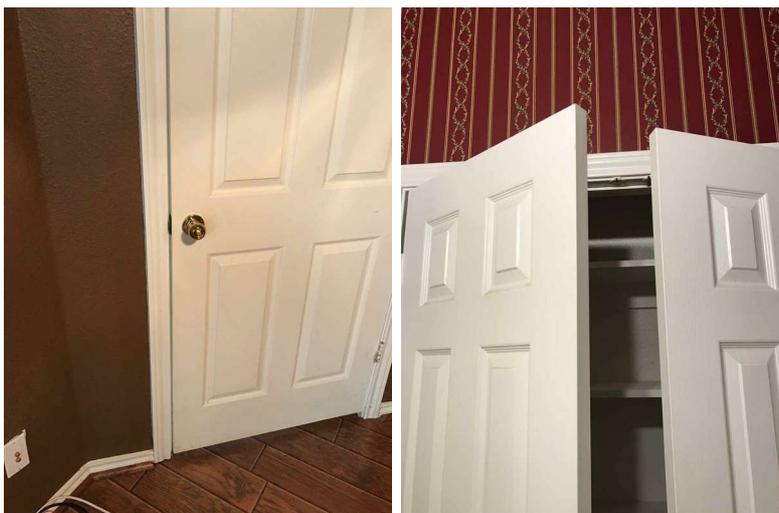
3: Door Sticks

- Door sticks at master bedroom entrance
- Hall bathroom closet top latch door hardware is very tight/sticky, making it difficult to open / close door(s)

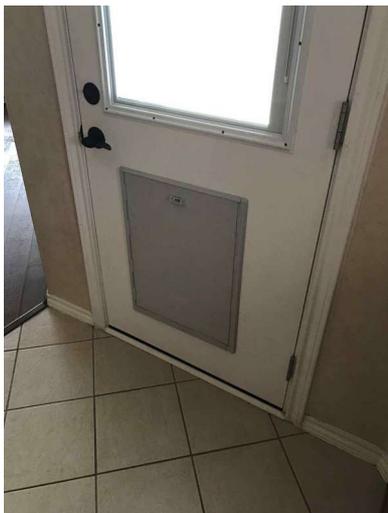
5: General Deficiency

- Very large dog door is present in the exit door to patio; this creates a potential security risk as a human could easily enter through the dog door

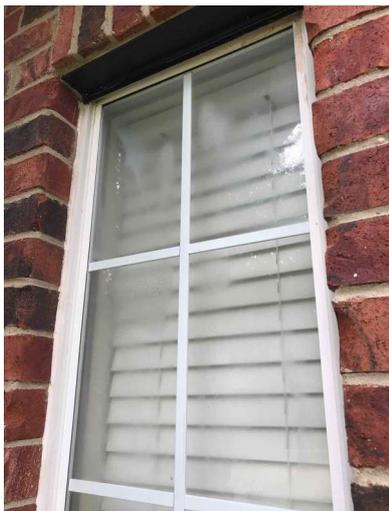
2: Solar Screens on Bedroom Windows (clipped on)

- Some bedroom windows are covered with solar screens, screens are clipped on from the outside and should be removable if needed in case of emergency. Solar screens could potentially prevent emergency exit so I recommend client be certain screens can be easily removed if necessary in emergency situation

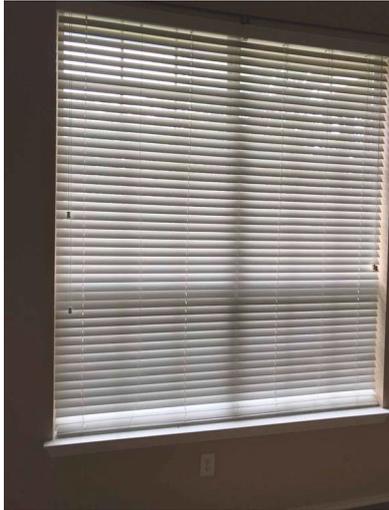
3: Window Blinds / Shutters Deficient

- Some window blinds are broken, not functioning properly

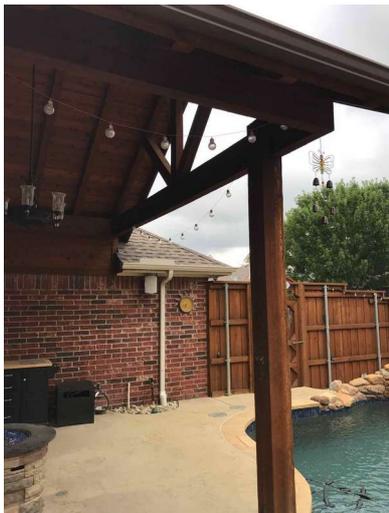
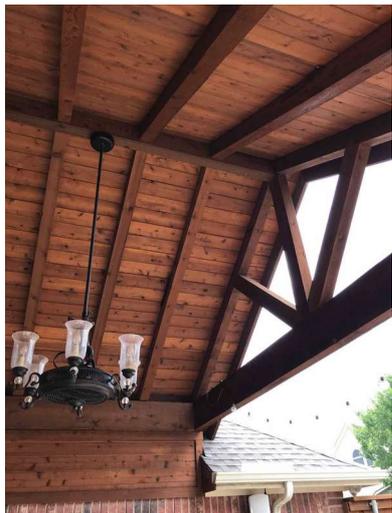
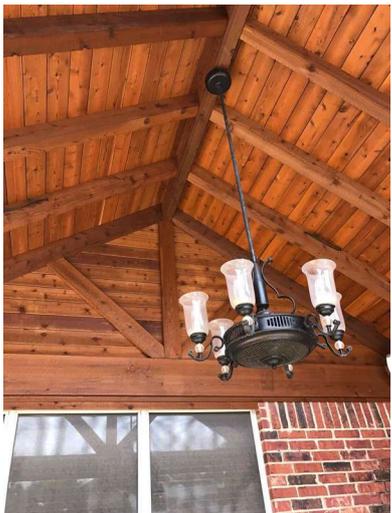
Porch Cover Condition:

- The porch cover was visually inspected and generally appears to be in sound condition and functioning as intended

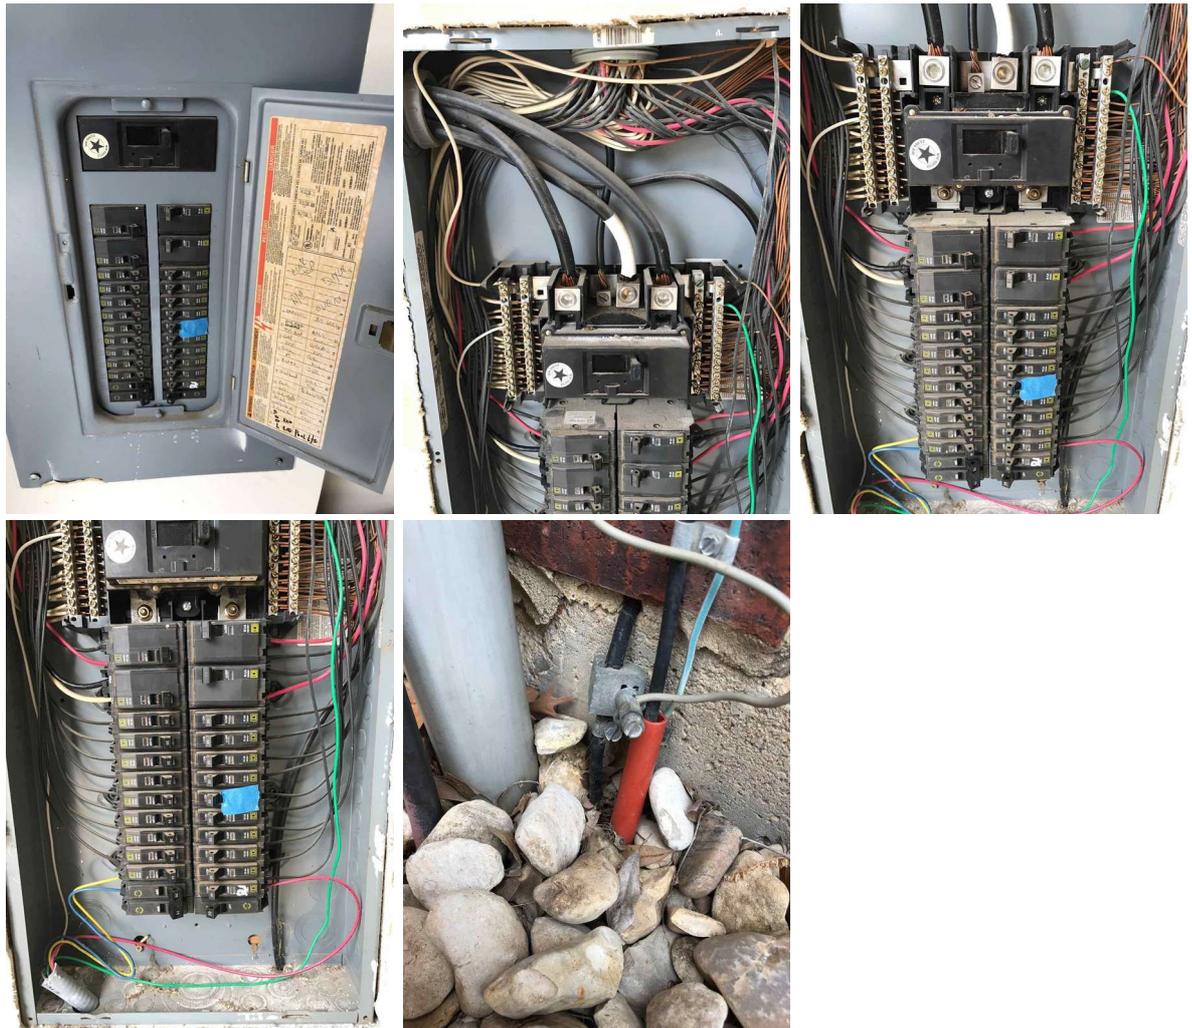
Panel Observation:

The panel cover was removed for visual observation of the electrical components inside (photos provided for reference)

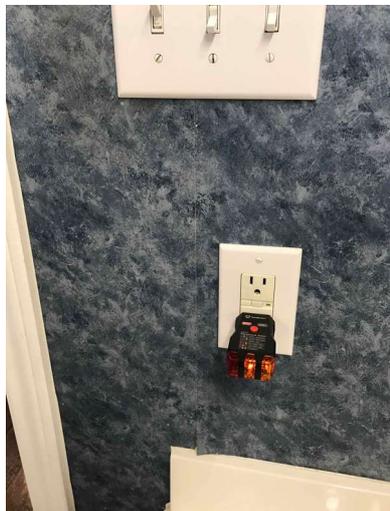
1: GFCI Protection Missing

- There is GFCI protection missing in some areas of the home such as master bathroom left front counter top outlet. This is a GFCI type outlet, but outlet fails to trip under testing, so GFCI protection is not functioning, outlet should be replaced
- GFCI protection *is* present at all other required locations of the home

(Per TREC, GFCI outlets are required in all wet areas such as all kitchen counter tops, bathrooms, outdoor locations and garages)

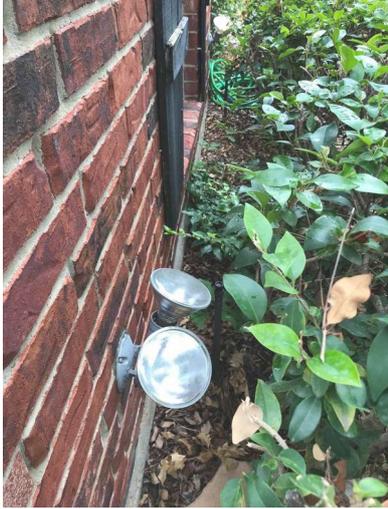
2: Light Inoperable

- Light bulbs at some fixtures are removed or not working as intended. I cannot verify if the fixture itself is functioning correctly, or if the light bulbs are simply burned out. (Photos are examples, some deficient fixtures may not be included in photos below)

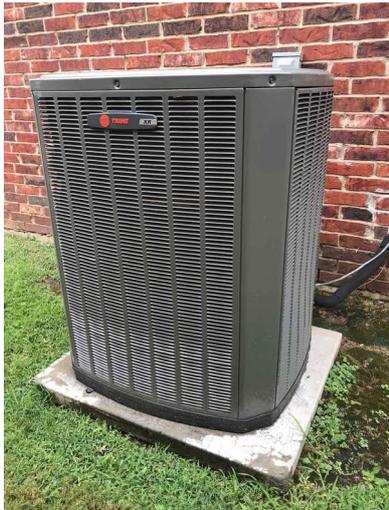
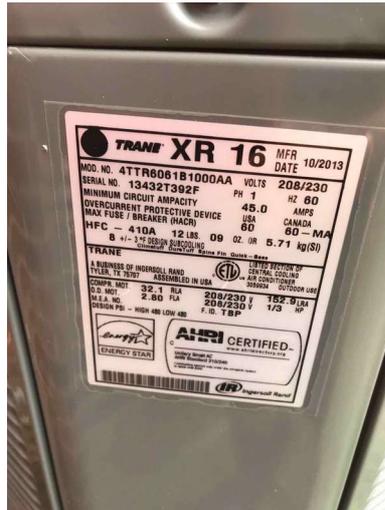
A/C System Temperature Differential : 17 degrees -

Cooling system was run and tested. Average temperature of the air coming from vents was 60. Return air was measured at 77. The differential was 17. The recommended differential is at least 15-20 degrees. Therefore the system is considered to be performing at a satisfactory level

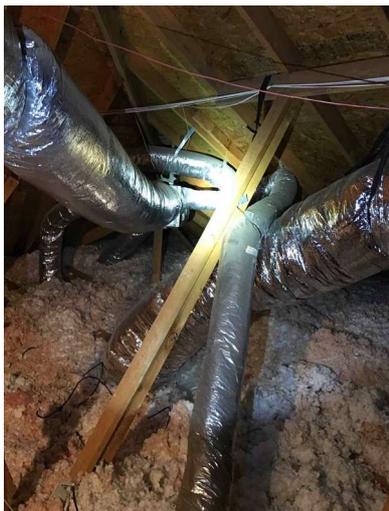
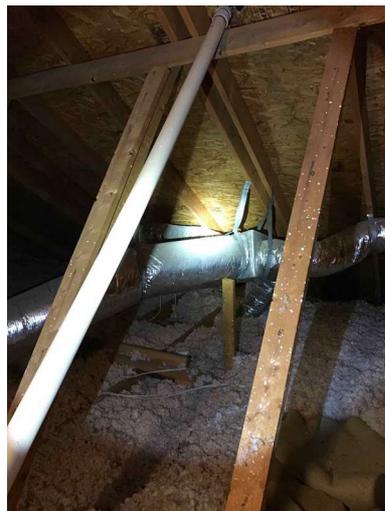
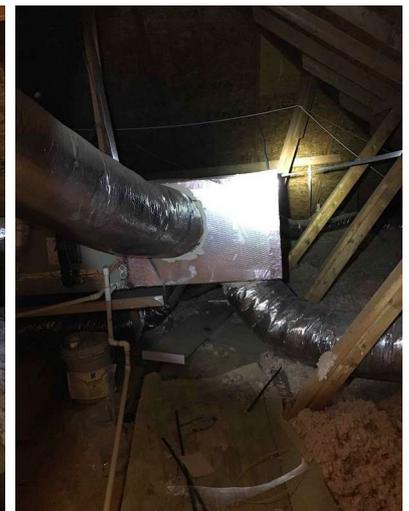
Duct system was observed from the attic (note that much of the duct work may not be visible to inspector due to obstructions, insulation covering ducts, etc.). All observed ducts appear to be properly connected and fully insulated. I did not observe any obstructions or collapsing of duct openings

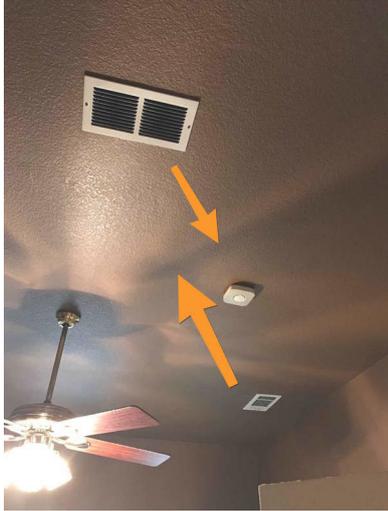
1: Vent Cover Improper

- In the master bedroom ceiling, the return air and supply air vent covers have been reversed / installed crisscrossed. These 2 vent covers should be exchanged for proper vent operation

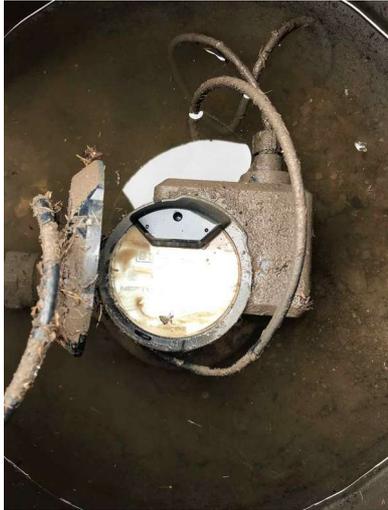
*Static Water Pressure Reading: 107 PSI -
(should be between 40-80 PSI)*

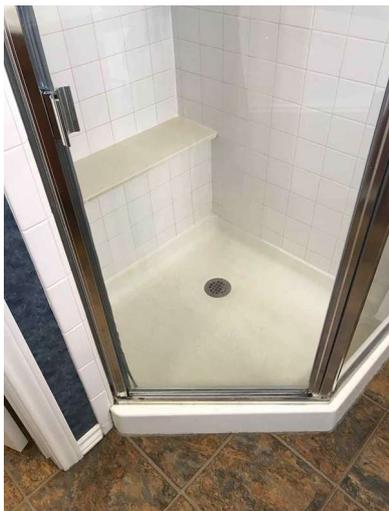
2: Shower Door Seal

- Gasket seal along edge of shower door is damaged

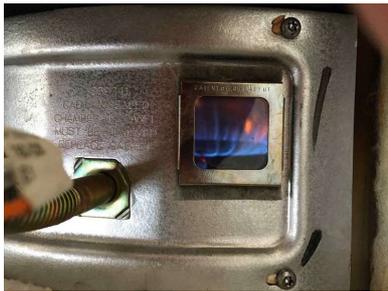
Proper Operation Verified: Unit came on when triggered by water heater thermostat. Flame was observed and burned blue and without disruption; indicating proper operation

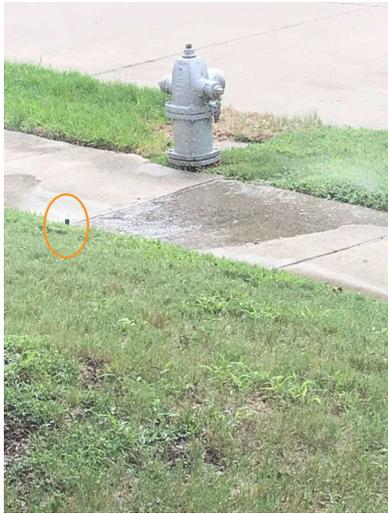
1: Broken Sprinkler Head(s)

- Broken sprinkler head noted at zone 3, at edge of front sidewalk

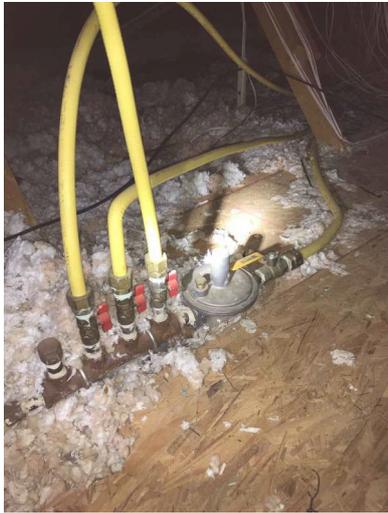
- I did not observe a grounding / bonding wire connected to the CSST line in the attic, so it appears that the CSST may not be electrically bonded as it should be

- I cannot conclusively assess the safety or proper installation of the CSST in the house. If you have any concerns about potential risks associated with CSST, I recommend you consult a licensed electrician with expertise on this issue and/or a licensed electrician to discuss the bonding of the CSST. To learn more about this technology you may visit www.csstsafety.com.
